GEOPOLYMER FOR REPAIR AND REHABILITATION OF REINFORCED CONCRETE BEAMS

Geopolymer for Repair and Rehabilitation of Reinforced Concrete Beams

by P. Balaguru, Professor
Stephen Kurtz, and Jon Rudolph, Research Assistants
Rutgers The State University of New Jersey
Piscataway, NJ -08855-0909, U.S.A.

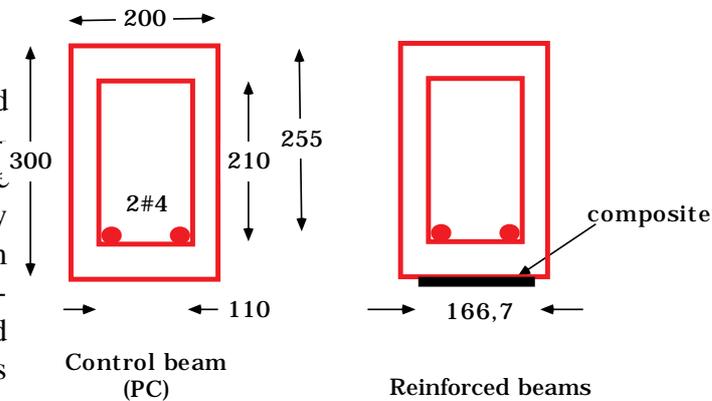
Figure 1: Beam Cross Sections

Four reinforced concrete beams that were 10 ft. 6 in. (3200 mm) long, 7.875 in. (200 mm) wide and 11.813 in. (300 mm) deep were constructed. These beams were tested over a simply supported span of 9 ft 10 in. (3000 mm). The reinforcement details of the beams are shown in Fig 1. The tension reinforcement consisted of 2#4 bars.

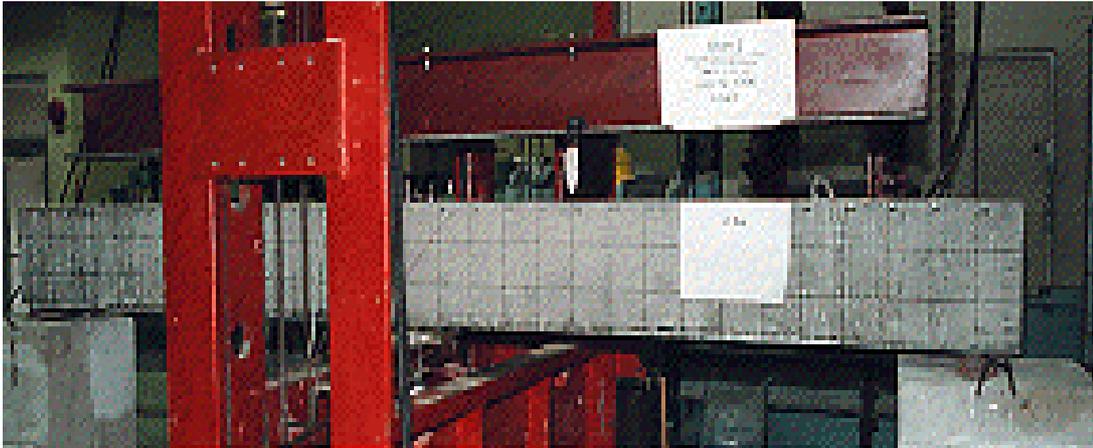
Figure 2: Beam Prior to Start of Testing

The beams were instrumented to measure strains in concrete, tension steel, and the composite; and the deflections. The strain values in the composite can be considered only as average values because the gages were glued to both the fibers and the matrix. The beams were simply supported over

a span of 9 ft 10 in (3000 mm) and two concentrated loads were applied at 3 ft. 3.3 in. (1000 mm) from the supports. The loads were measured using MTS data logging systems. The beam set-up, ready for testing is shown in Fig 2.

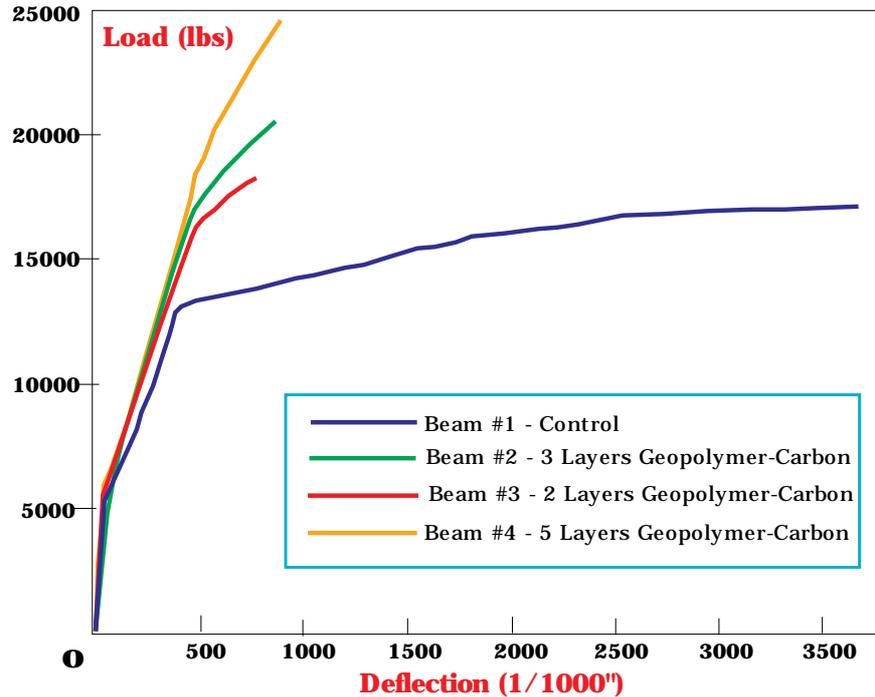
Figure 3: Load vs Deflection. All Beams

As expected, the stiffness of the beam increased with the number of layers of fabric as indicated by the decrease in deflection, shown in Fig. 3. The depth of neutral axis seem to increase with the number of layers. This should also be expected because increased tension force for a given curvature requires increased compression force. Since the strength of concrete is the same, the increased compression force capacity has to come from increased compression force provided by a larger depth of neutral axis.

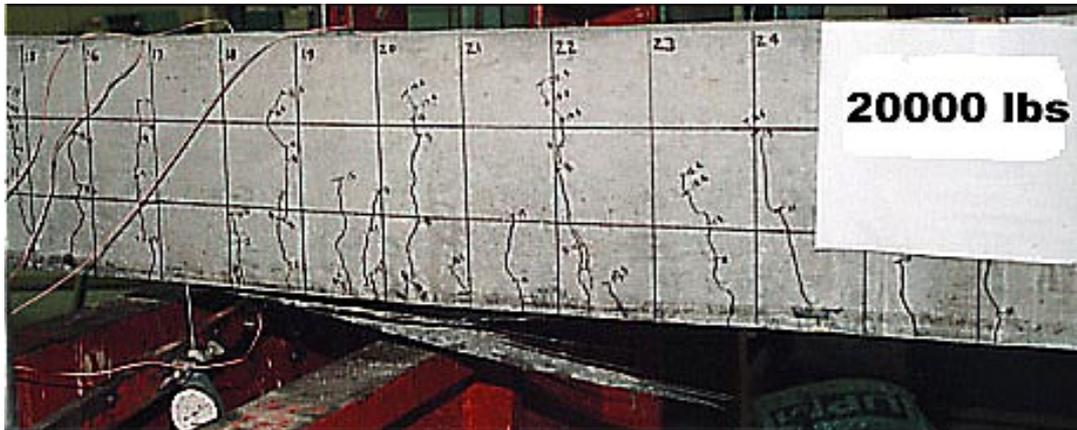
Figure 4: Cracking Pattern for Beam # 2 at 20000 lbs Load, after Rupture of Composite (bottom)

The crack patterns of strengthened beams are different from the control beam. Strengthened beams had more cracks and were more closely spaced. As the number of layers increased, the length of the beam over which extensive cracking occurred also increased. Maximum crack widths were smaller for the strengthened beams. Typical crack patterns are shown in Fig. 4.

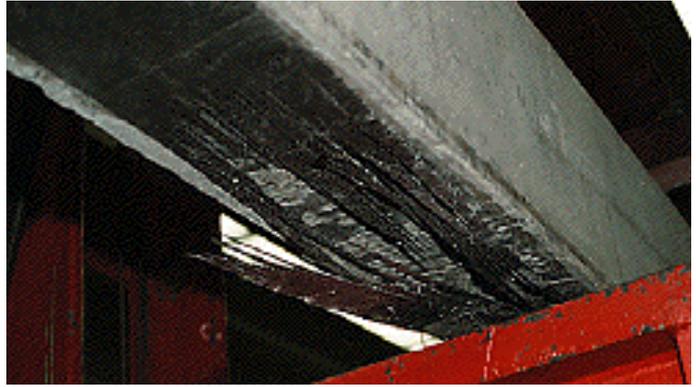
Figure 5: Rupture of Geopolymer-Carbon composite

The primary difference between the organic polymer and the geopolymer is the failure pattern. In the Sherbrooke study, the composite peeled off, whereas the composite ruptured in the current study (see Fig 5). Delamination failure not only underutilizes the composite strength, but is also extremely brittle. This type of failure must be avoided at all costs, in order to provide warning of the impending failure.

As mentioned earlier, all the strengthened beams failed by rupturing of the composite. This shows that geopolymer provides effective adhesion even when five layers of fabric were used. In practice, the number of fabric layers have to be limited to 3 or 4 for economical reasons. Hence, if the repair system is properly carried out, failure by delamination of composite can essentially be eliminated. Since the beams were purposely underreinforced with sufficient shear reinforcement, shear failure did not occur even when the moment capacity was increased by 50 percent over the control beam. As the
